# **PROPERTY CONDITION ASSESSMENT**

**INSPECTED FOR  
DAVID GREEN  
2025 Parkway Drive  
San Fernando, CA 90702  
January 05, 2011**

**REF: Property Condition Assessment of 19300 Victory Boulevard, Los Angeles**

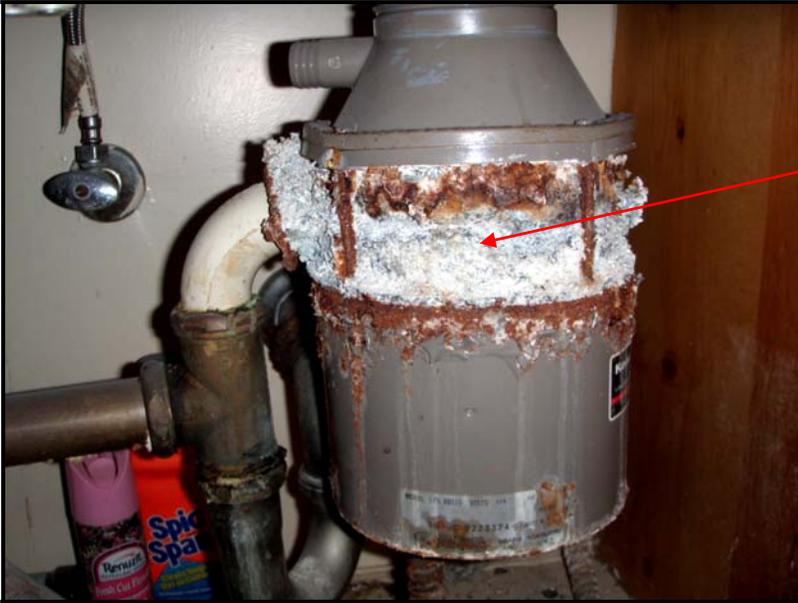
**Photo #4**

Corroded and leaking garbage disposer in the kitchen of Unit #9 in Bldg. #206

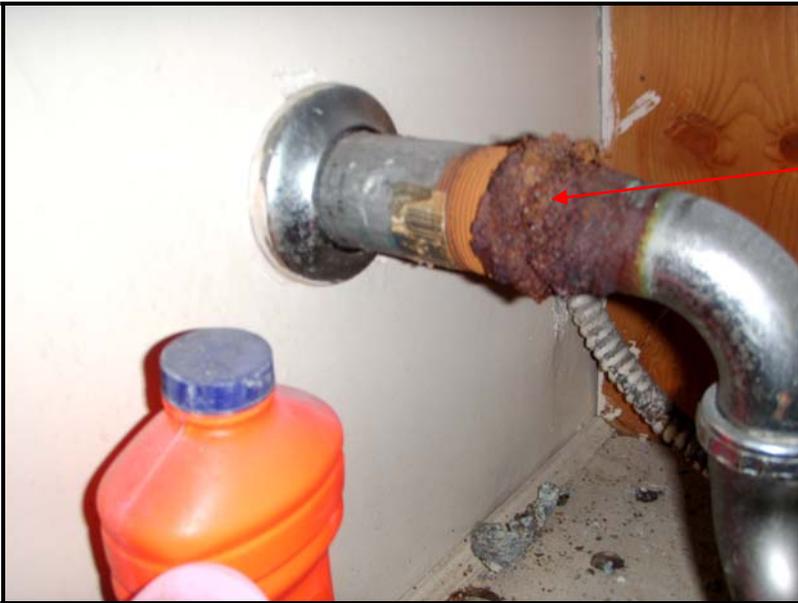
**Photo #5**

Corroded and leaking kitchen sink drainpipe in Unit #9 of Bldg. #206

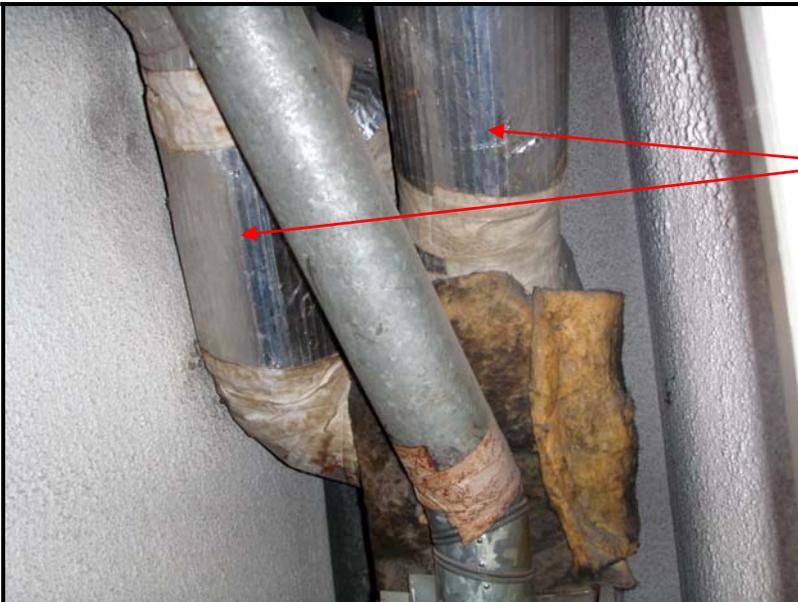
**Photo #6**

Asbestos insulated metal ductwork of forced air furnaces

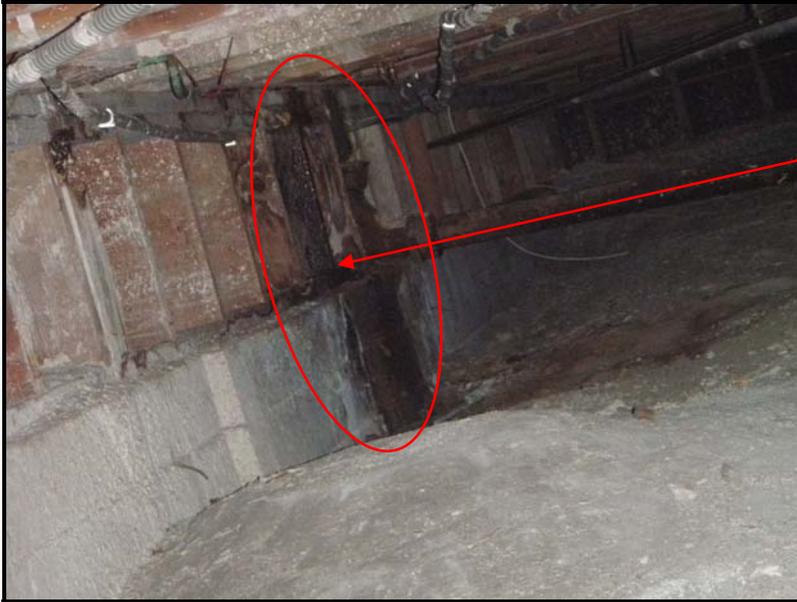
**Photo #7**

Major leak waste pipe in underfloor space of building #200

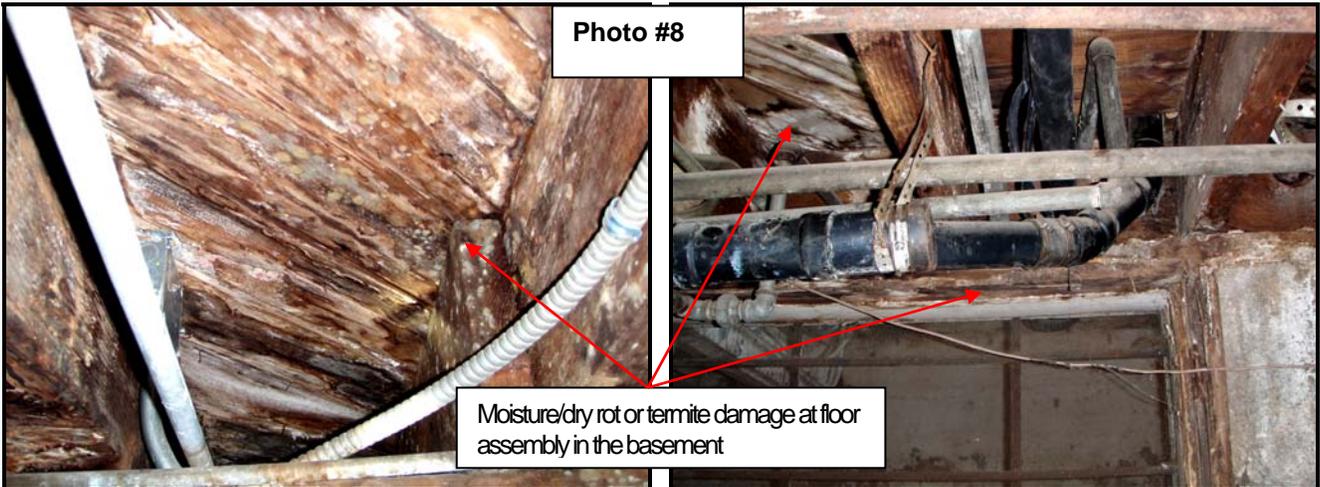
**Photo #8**

Moisture/dry rot or termite damage at floor assembly in the basement

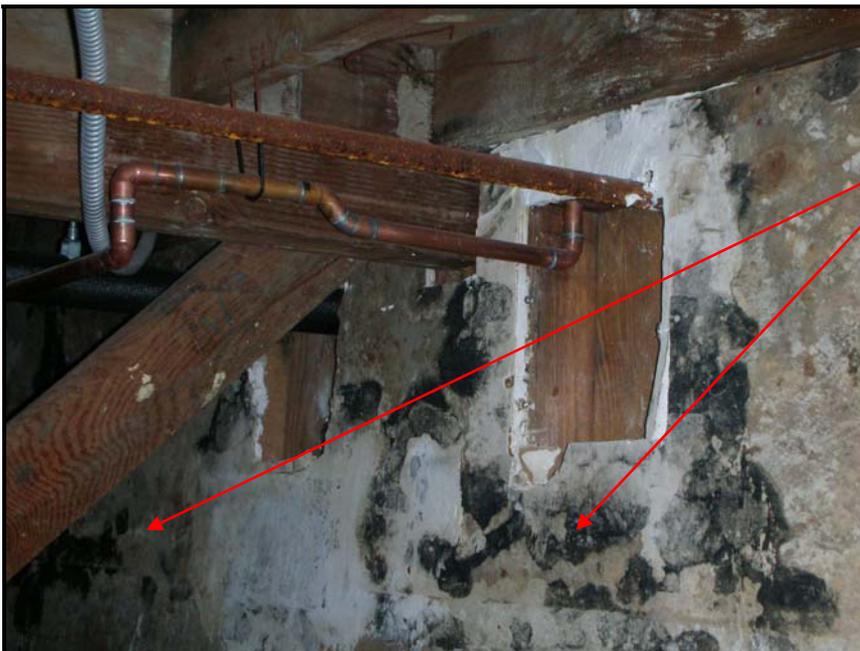
**Photo #9**

Heavy mold growth at fire barrier wall
